## Liquid Mixing Manifold (LXM) Visual Position Indicator Issue

### Issue

The Visual Position Indicator (VPI) on some LXM actuators may remain in the “Open” position when the actuator returns to the “Closed” position.

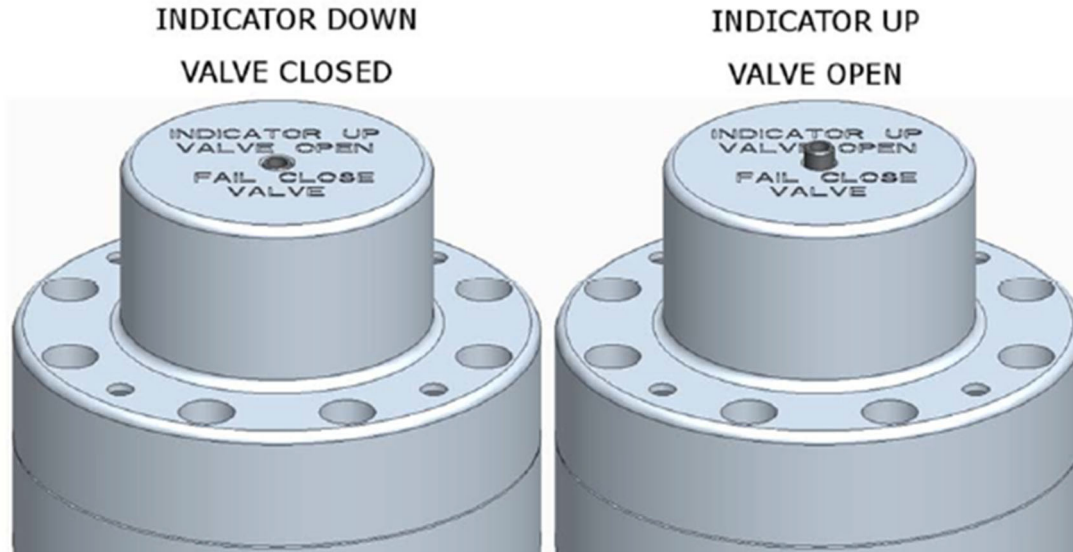
The VPI may remain in the Open position if the VPI rod disengages from the actuator piston due to low retention force of the rod and high friction between the rod and the environmental seal located in the actuator cover.

The position of the actuator can be verified by inspection of the visual indicator at the top of each actuator. When an actuator is open, the indicator rod protrudes from the actuator cover by approximately 6 mm / ¼ inch; when the actuator is closed, the indicator rod is flush with the actuator cover.

**Permanent Corrective Action:** A design change was implemented to prevent the issue by increasing the retention force between the VPI rod and the actuator piston. Lubrication will also be added to minimize the friction between the VPI rod and the environmental seal.
